A Hybrid Experimental-Numerical Framework to Improve the Repair Quality of Wind Turbine Blades by Cold Spray

Research Overview

- The repair process using cold spray technology is the main focus of this project, which investigates the deposition of thermoplastic coatings on fiber reinforced polymer composites. This project uses multiscale finite element analysis (FEA) to study the bonding mechanism.
- Through this cutting-edge technology, mechanical properties of damaged composites are significantly recovered.
- Cold spray technology is an efficient method for repairing damaged composites due to its ability to produce thick coatings with strong adhesion and stiffness.

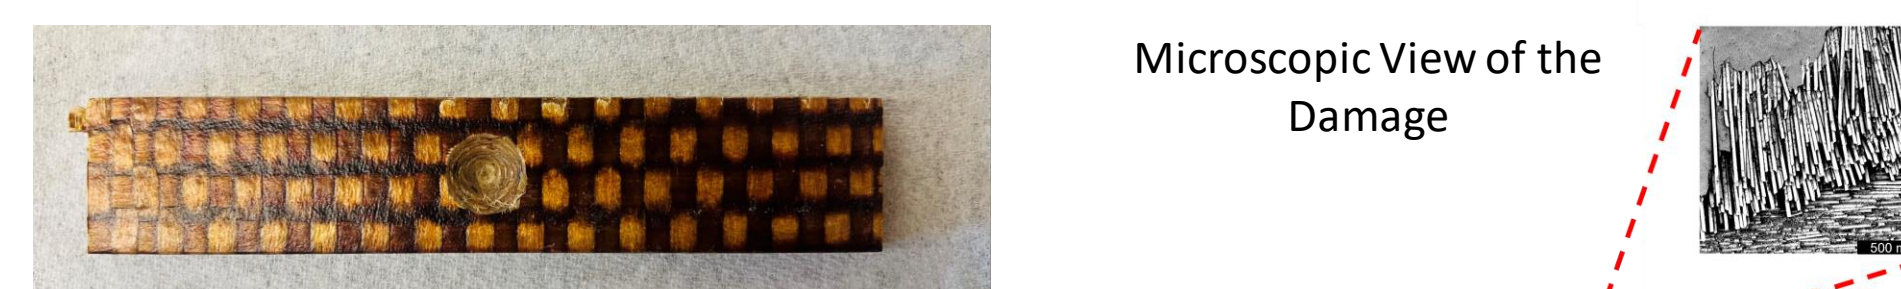
Damaged Turbine Blade Materials Repaired with Cold Spray:

- Damage prepared on the sample by conventional drilling process
