SITE INVESTIGATION REPORT FORMER FEDERATED METALS PROPERTY ENTERPRISE AVENUE CITY OF TRENTON, MERCER COUNTY, NEW JERSEY

JUNE 25, 2008

PROJECT NUMBER 10043

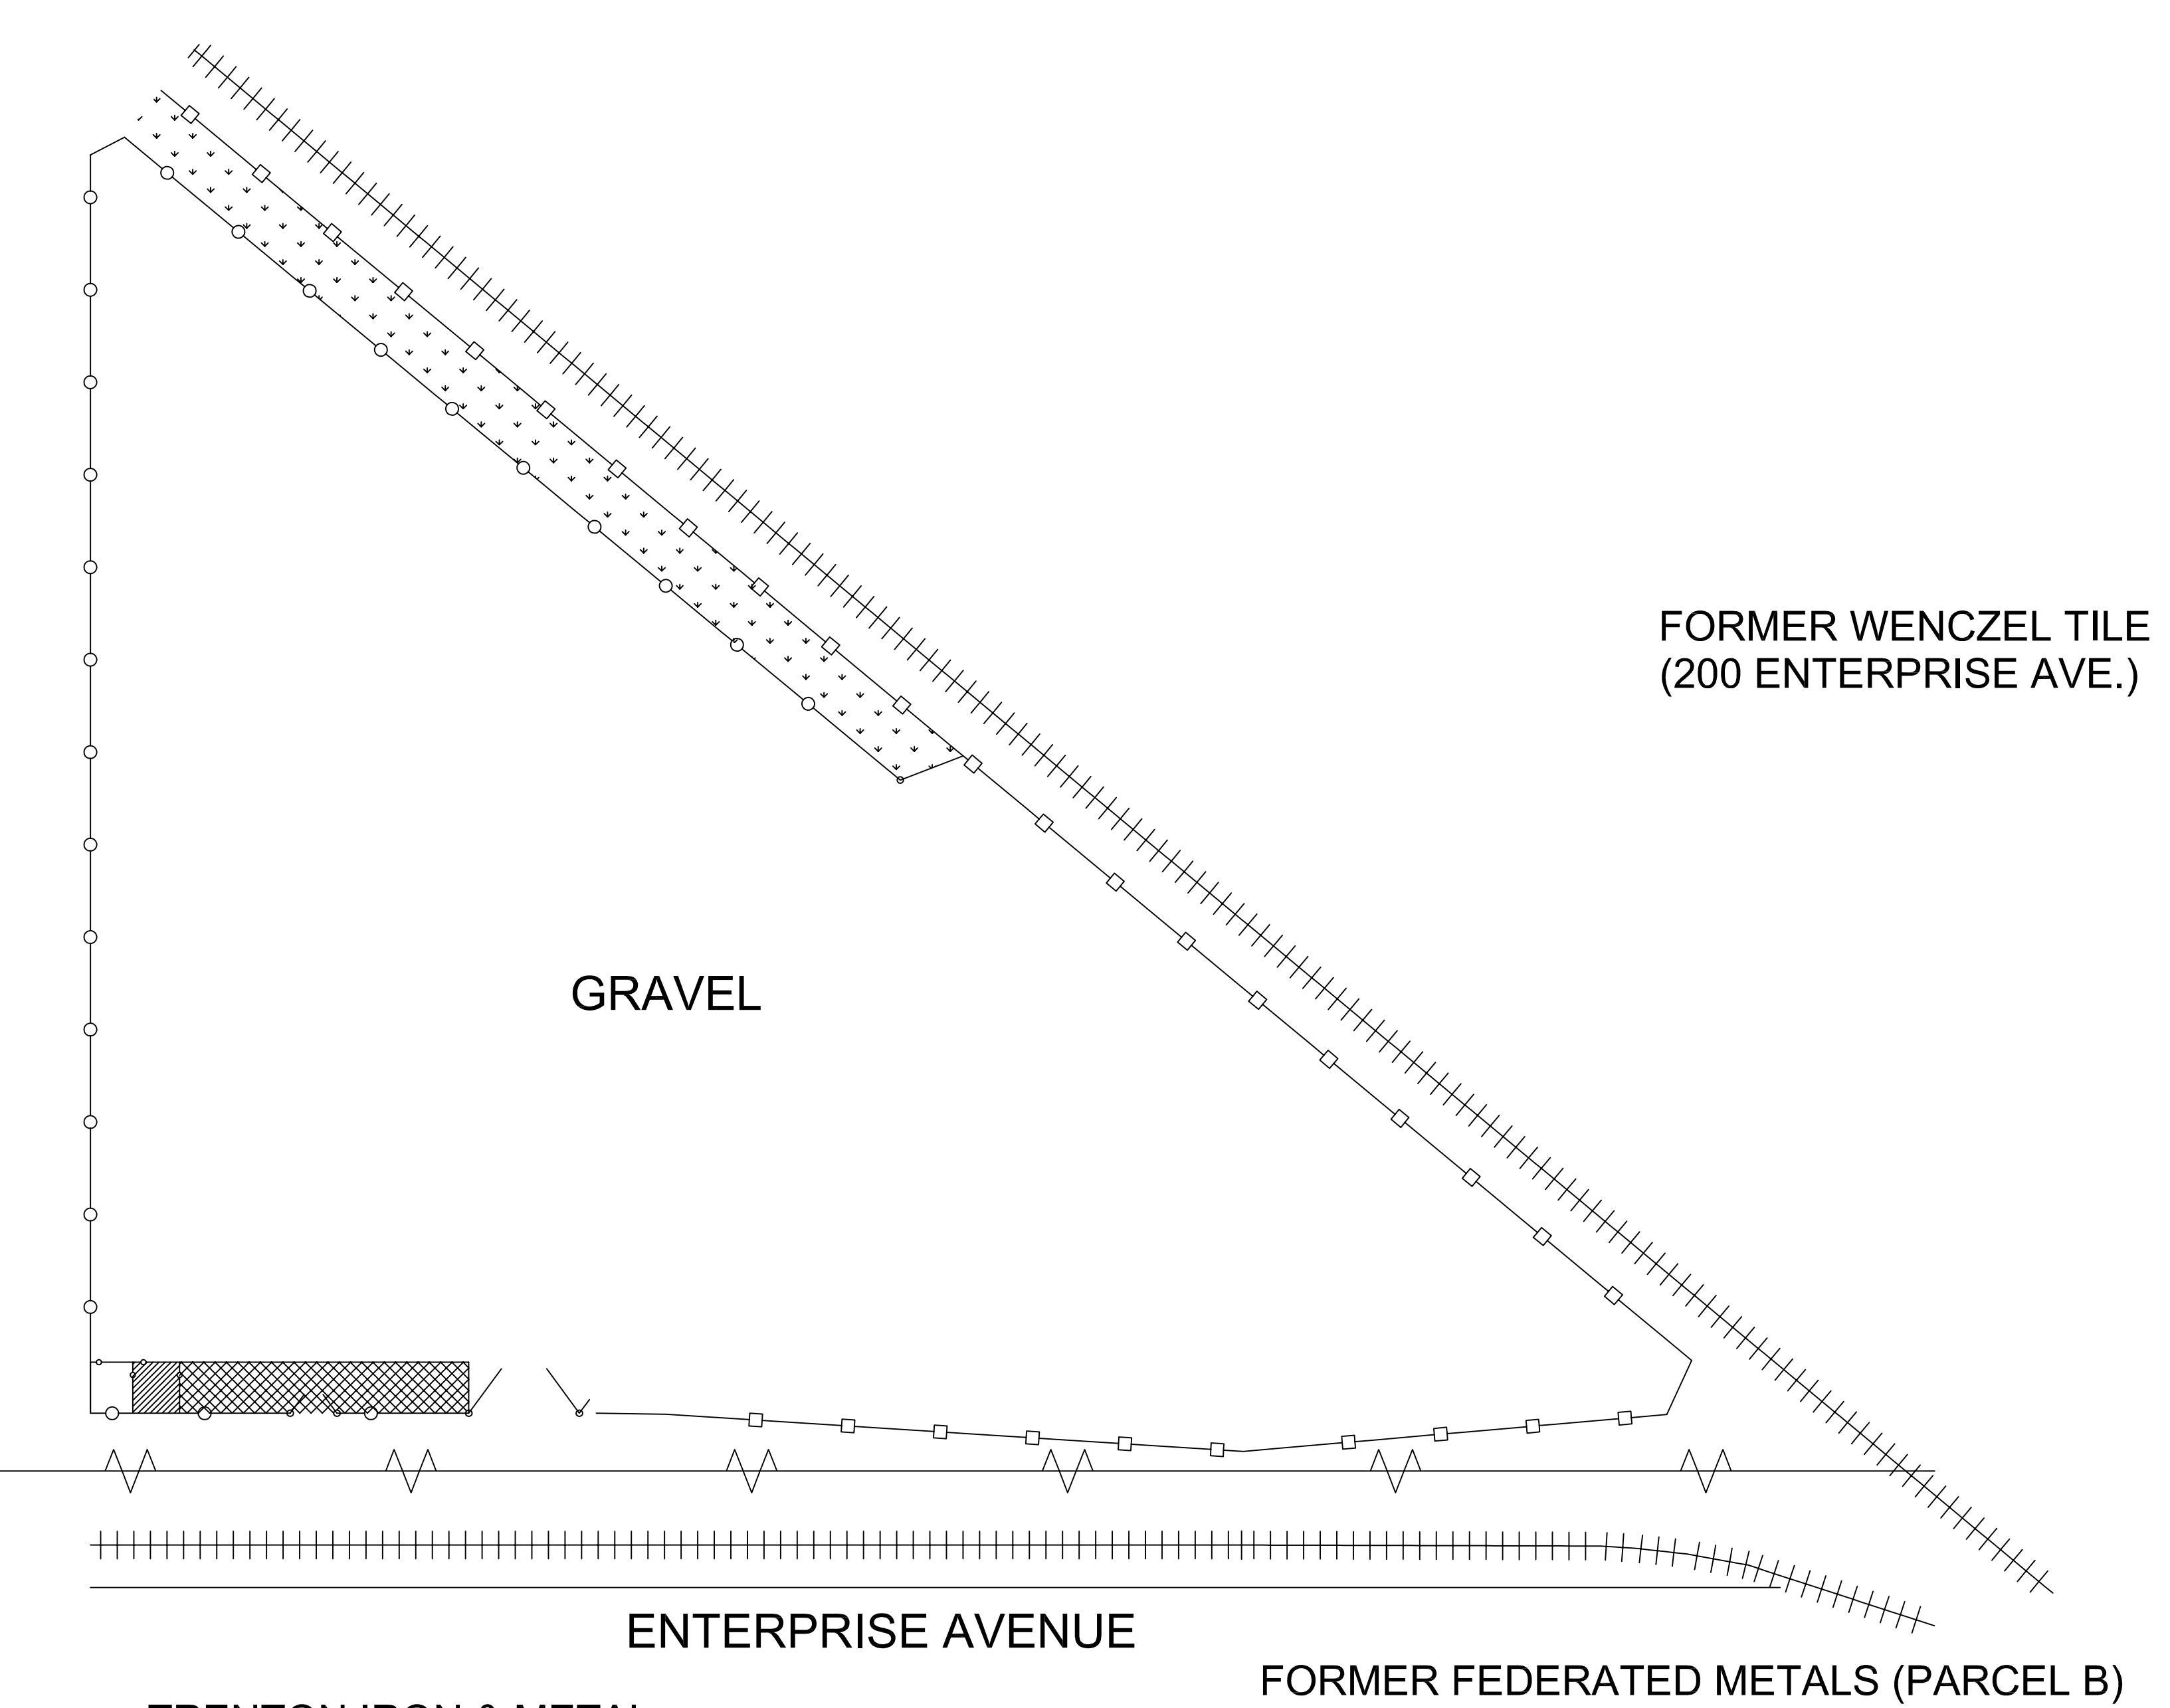
The approximately 4.6-acre Site consists of two vacant areas (Parcel A and Parcel B) separated by Enterprise Avenue. Parcel B is located to the northwest of Parcel A. No structures are located on Parcel A and Parcel B. Current Site conditions are shown on Plates 2A and 2B.

The approximately 1-acre Parcel A consists of a fenced-in triangular property. The fence surrounding Parcel A consists of older portions with several gates along Enterprise Avenue that match openings shown on the Parcel A facility map in Appendix B and newer portions adjacent to the railroad tracks to the south of the Site and along Enterprise Avenue on the western portion of the Site. The older and newer portions of the Parcel A fence are noted on Plate 2A. A fenced-in concrete pad formerly used for a transformer is located on the northern corner of Parcel A. The surface of parcel A consists primarily of gravel/cinder material. The area between the older and newer sections of fencing on the southern portion of Parcel A is overgrown. The remaining area is primarily clear of vegetation.

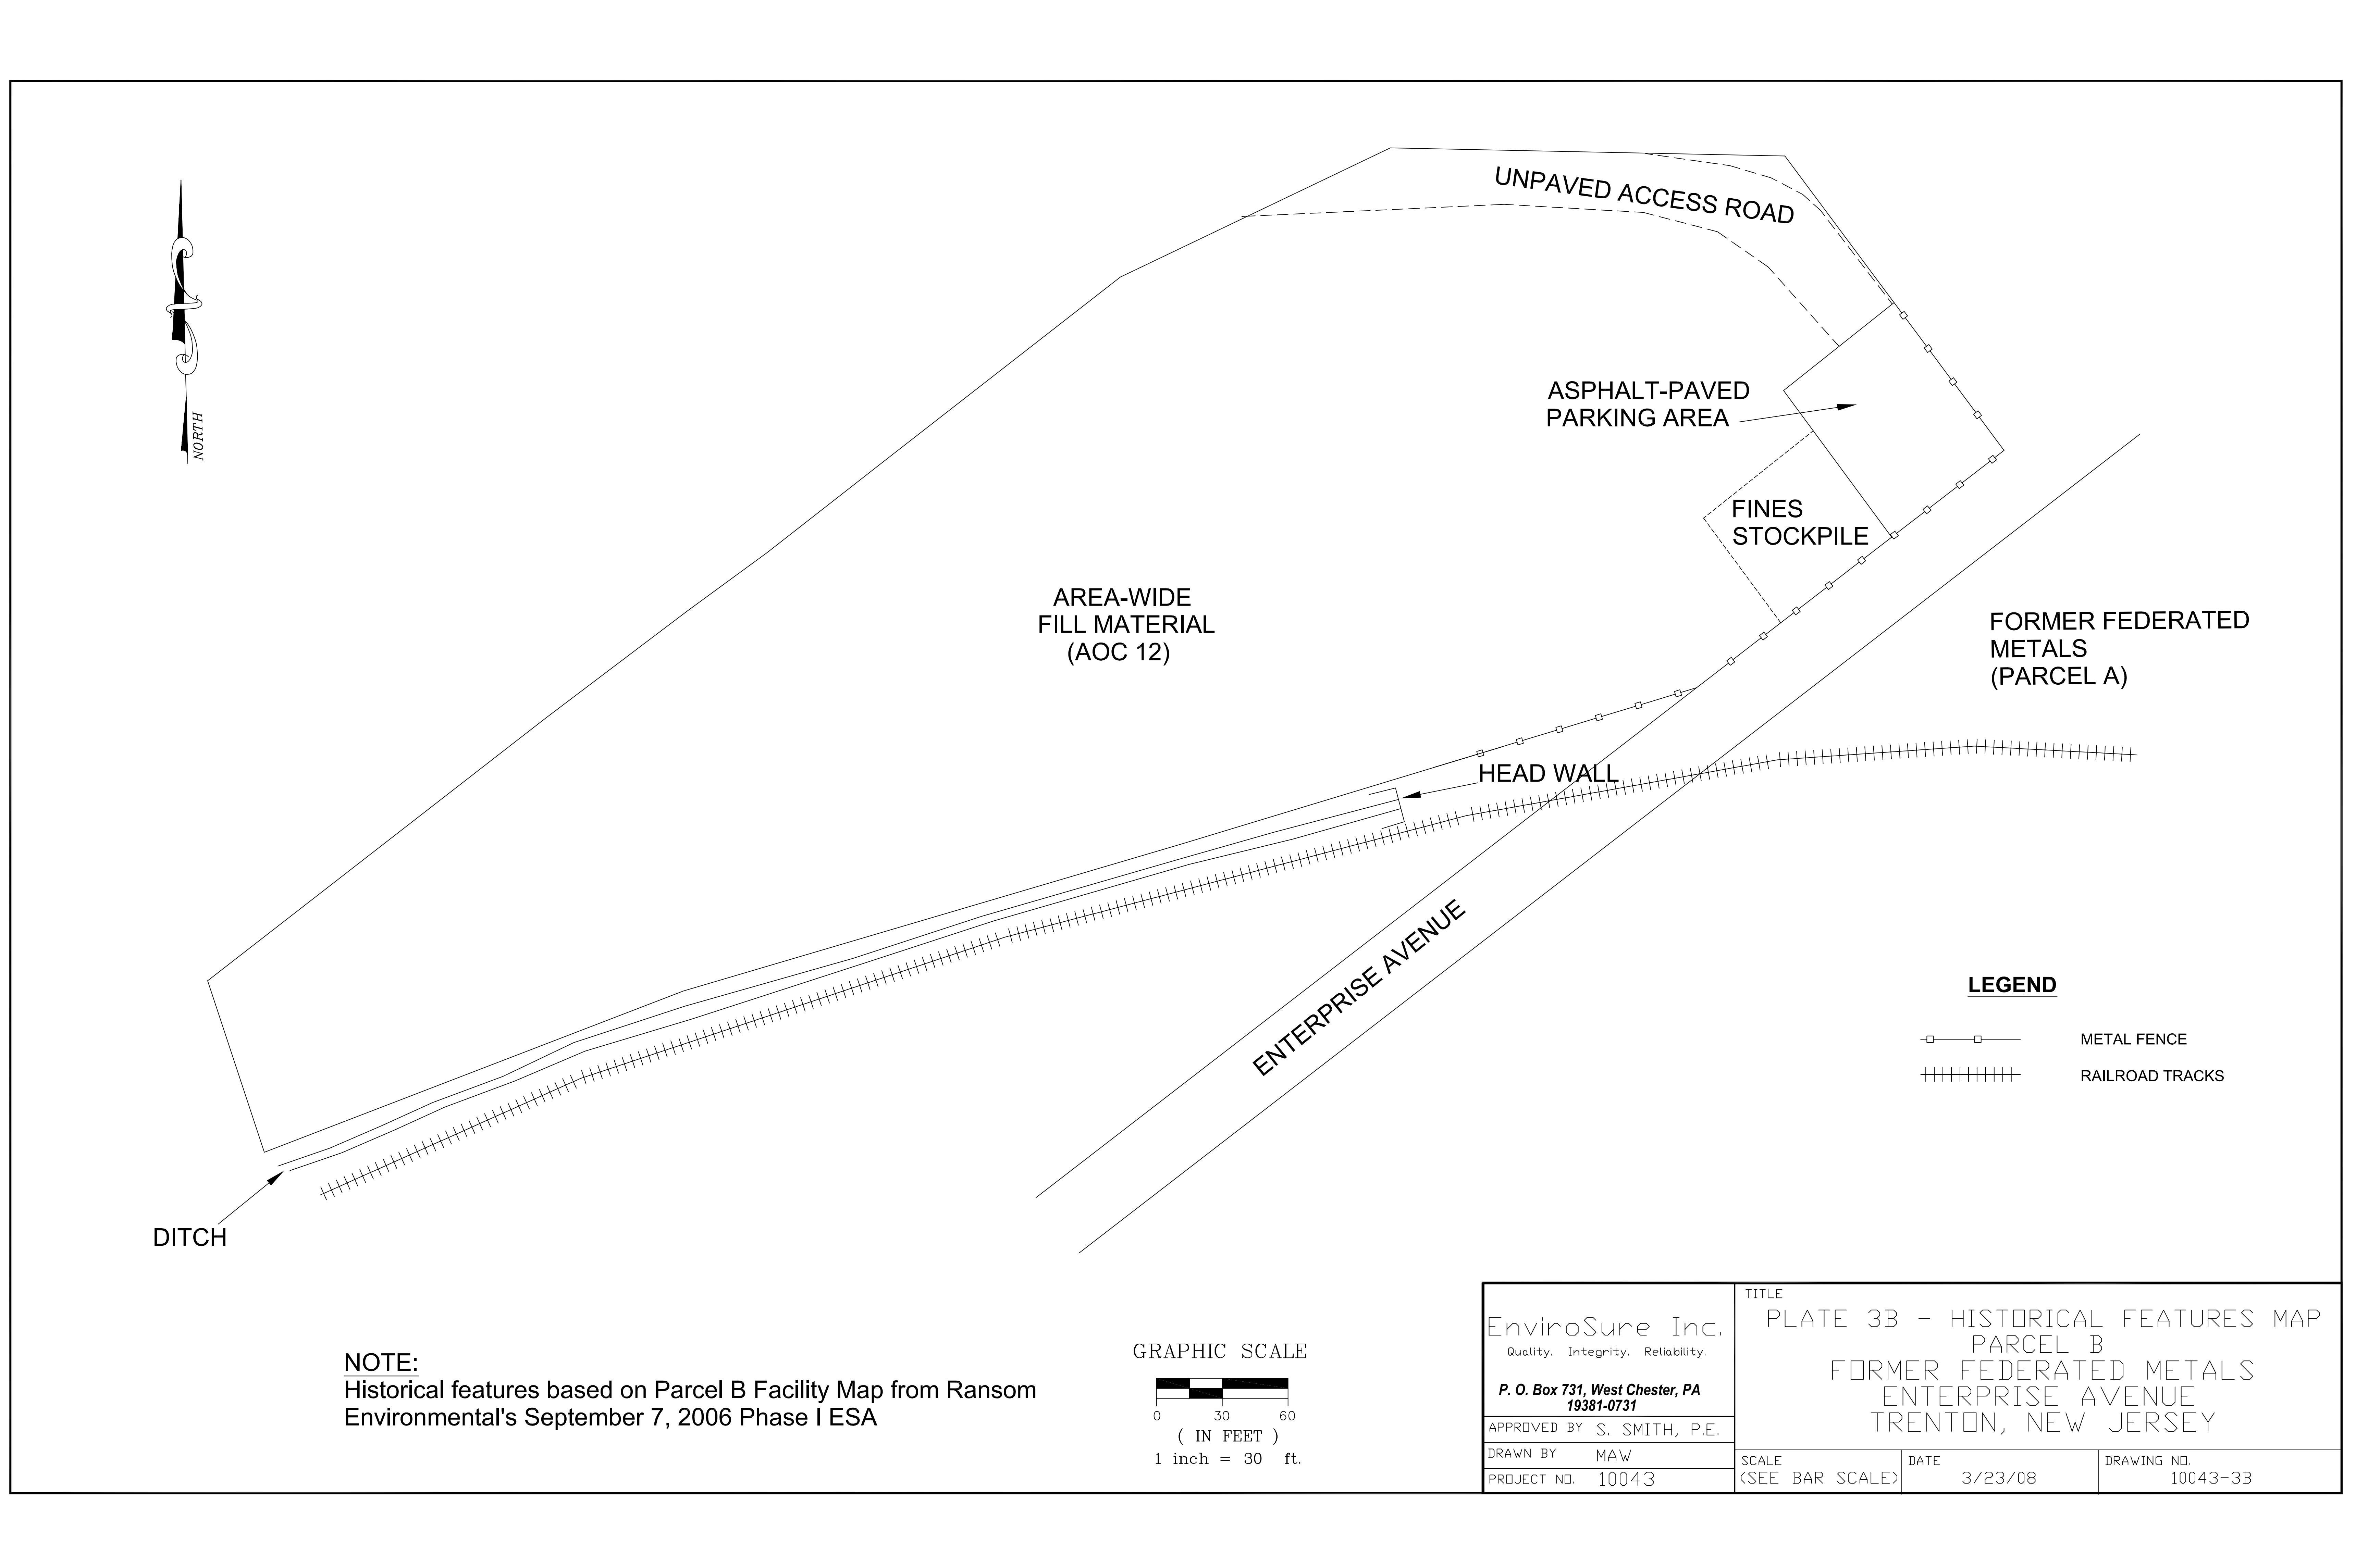
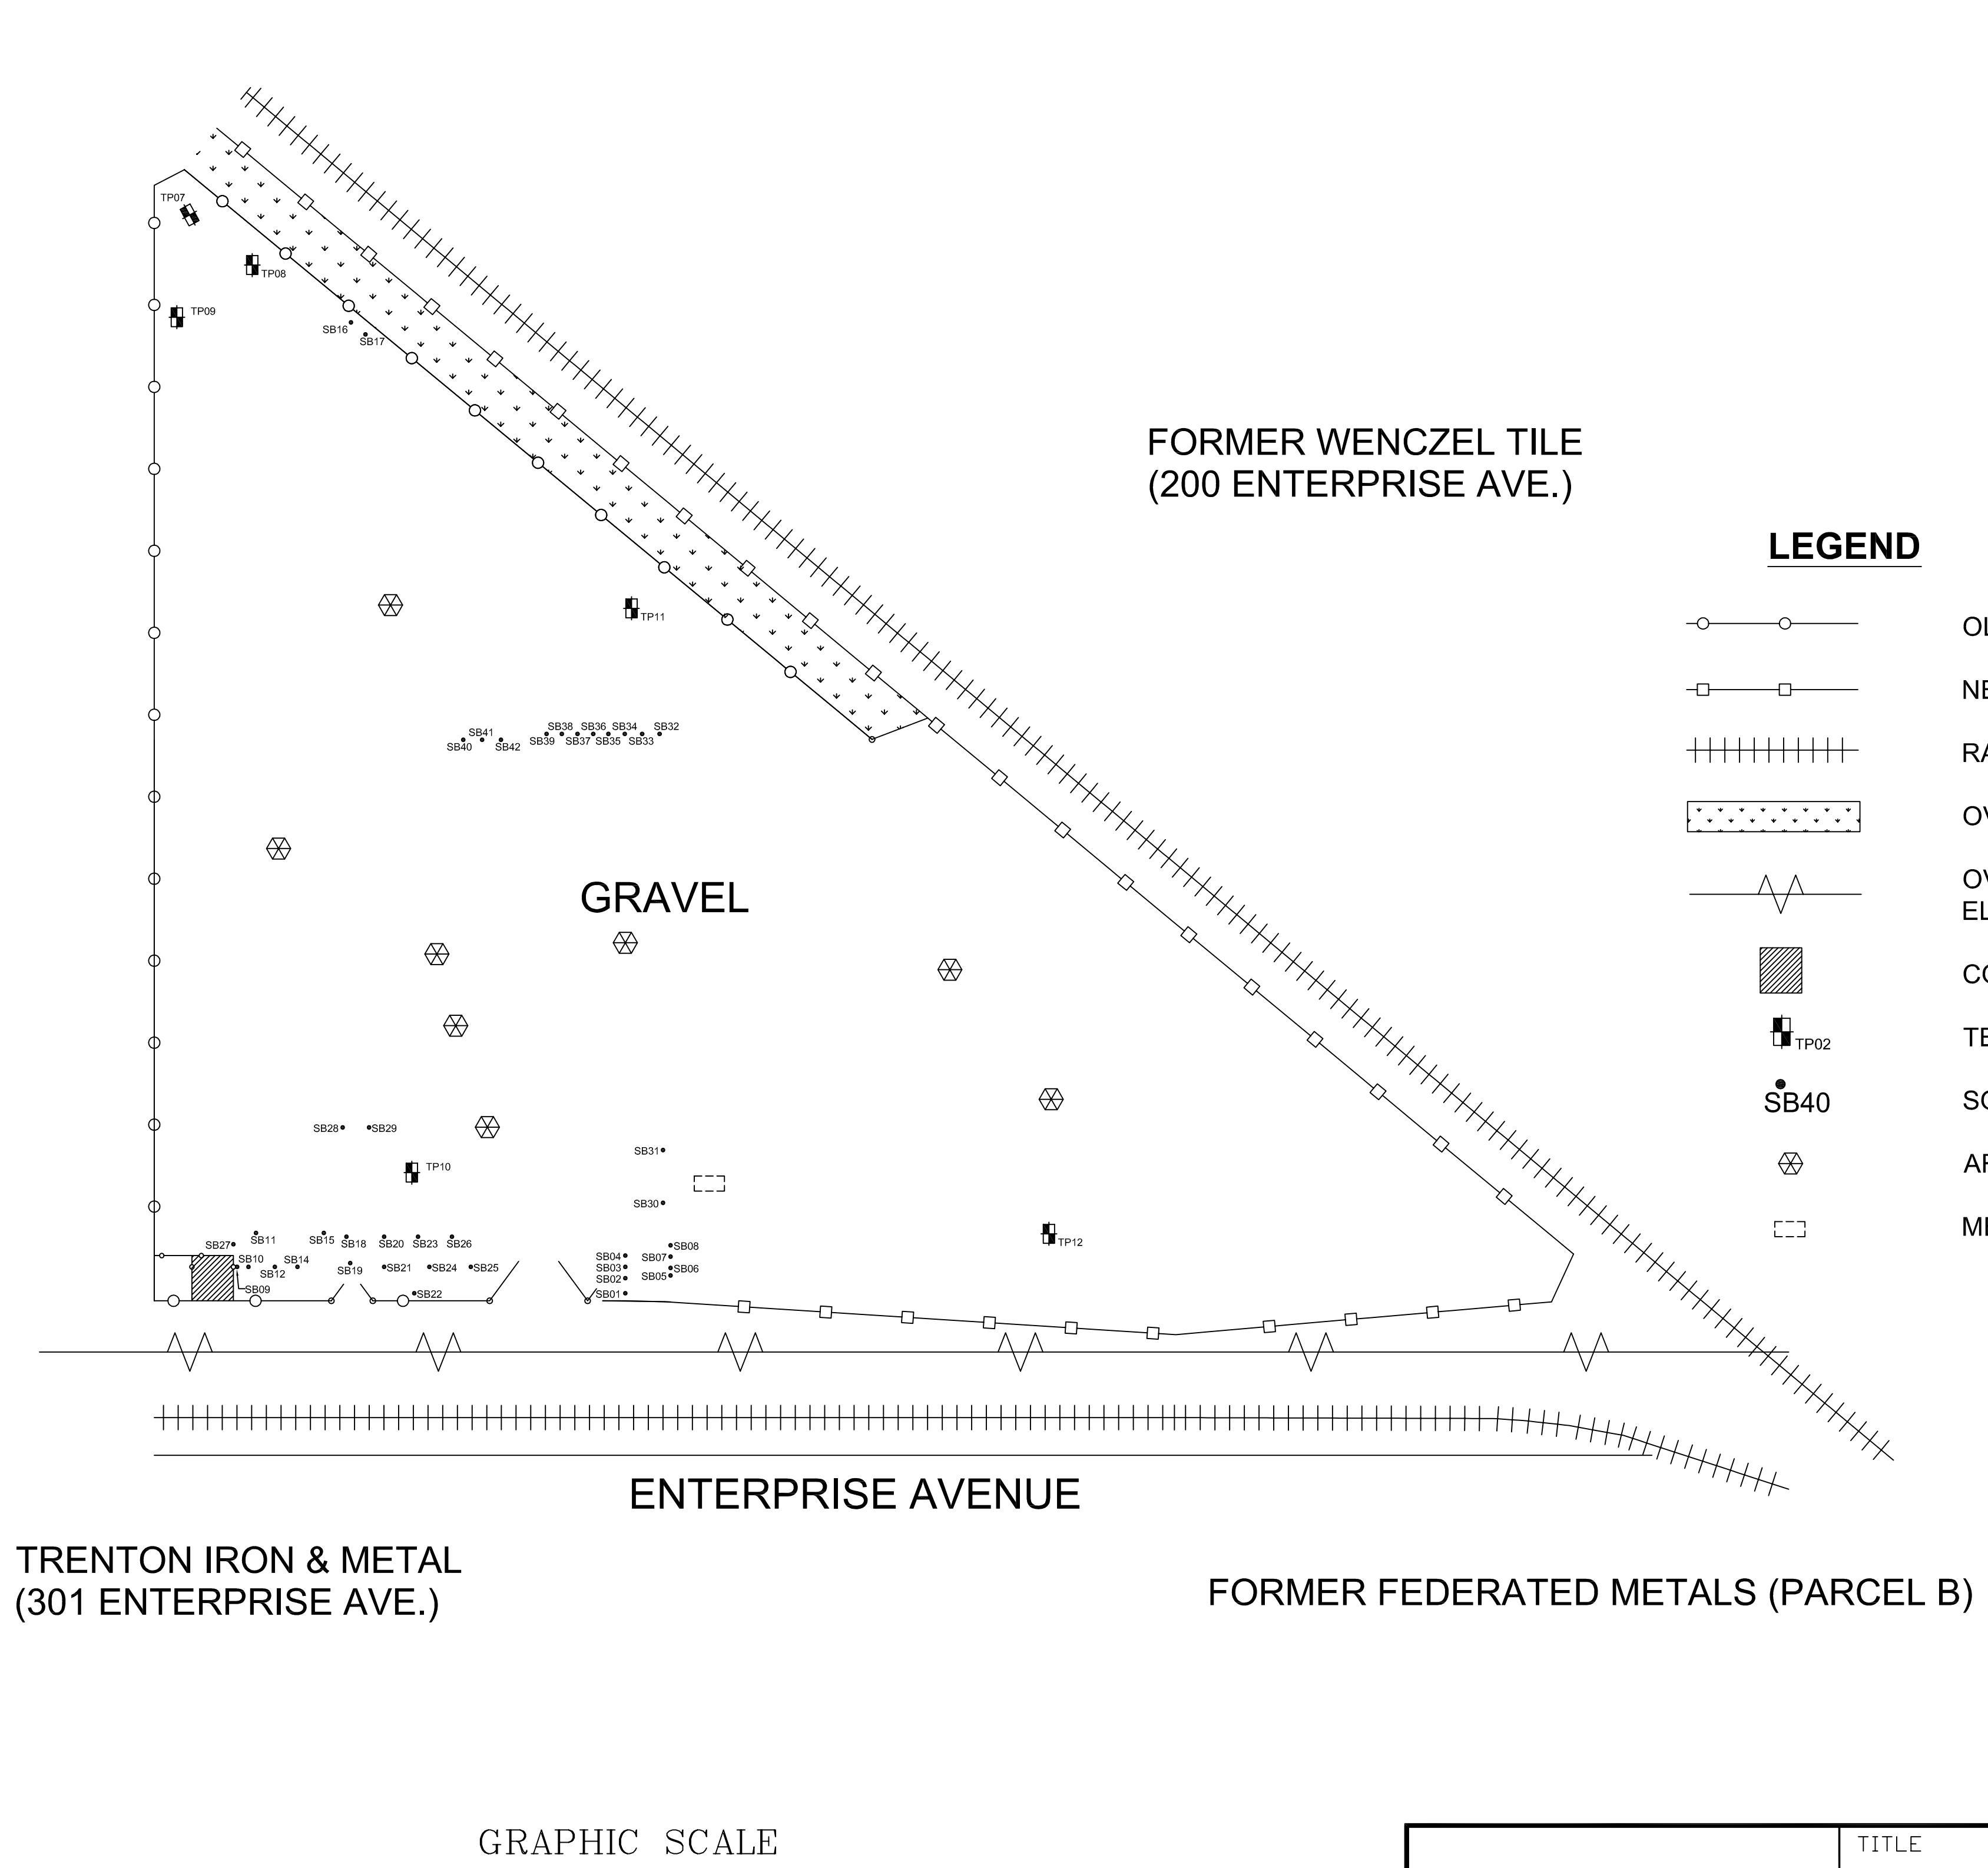
TITLE		
> Inc	PLATE 4	A – SAMPLE L	CATION PLAN
Reliability.		PARCEL A	\mathbf{h}
-	F DRM	ER FEDERATE	ID METALS
ester, PA	E	NTERPRISE A	VENUE
		FNITON NEV/	IFRSFY
IIIH, P.E.			
	SCALE	ΠΑΤΕ	
3	(SEE BAR SCALE)	3/23/08	10043-4A

ENVIROSURE directed use of a backhoe to investigate several areas that were identified during the geophysical survey. One of the anomalies was determined to be an approximately 4-ft by 8-ft 1/4-inch thick metal sheet located approximately 6-inches bgs. The remaining anomalies were most likely associated with rebar in the former concrete slab building foundation on Parcel A and scattered metal objects on the surface of Parcel A. The thick concrete foundation was encountered approximately 1-ft bgs and appeared to cover the footprint of the former main Site building. The backhoe was unable to break through the thick concrete foundation of the former building. As a result, the investigation of anomalies generally did not extend below 1-ft bgs and, as a result, test pit logs were not generated. No USTs or other environmental concerns were discovered during the further investigation of geophysical anomalies. The location of anomalies investigated are shown on Plate 4A.

One soil sample (SB27) was collected to characterize soil conditions associated with AOC 7 and analyzed for polychlorinated biphenyls (PCBs). The total concentration of PCBs in soil sample SB27 exceeded the NJDEP's NRDCSRS and RDCSRS.

Soil samples SB40 through SB42 were collected to characterize soil conditions associated with AOC 8. PCBs were not detected in soil sample SB41. The total concentration of PCBs in soil sample SB40 was below the NJDEP's NRDCSRS and RDSCRS. The total concentrations of PCBs in soil sample SB42 exceeded the NJDEP's RDCSRS.

Three soil samples (TP07 through TP09) were collected to characterize soil conditions associated with AOC 10. Soil samples TP07 through TP09 were analyzed for PPL metals. Concentrations of metals detected in samples TP07 and TP08 were below the NJDEP's NRDCSRS and RDCSRS. The concentration of lead (987 mg/Kg) detected in soil sample TP09 exceeded the NJDEP's NRDCSRS and RDCSRS. Thallium was not detected in soil sample TP09. However, the reporting limit of thallium (5.6 mg/Kg) exceeded the NJDEP's RDCSRS.

ENVIROSURE recommends delineation of the extent of petroleum-impacted soil exceeding the NJDEP's SRS. ENVIROSURE recommends a groundwater investigation of AOC 1 based on field observations and laboratory analytical results showing petroleum-impacted soil at and immediately above the groundwater level. In planning the groundwater investigation and soil contamination delineation work, the location of similar contamination at and immediately above groundwater levels in AOC 4 and AOC 6 should be considered.

ENVIROSURE recommends delineation of the extent of petroleum-impacted soil exceeding the NJDEP's SRS. In addition to further investigation of soil contamination, ENVIROSURE recommends a groundwater investigation of AOC 4 based on field observations and laboratory analytical results showing petroleum-impacted soil immediately above the groundwater level. In planning the groundwater investigation and soil contamination delineation work, the location of similar contamination immediately above groundwater levels in AOC 1 and AOC 6 should be considered.

ENVIROSURE recommends delineation of the extent of petroleum-impacted soil exceeding the NJDEP's SRS. In addition to further investigation of soil contamination, ENVIROSURE recommends a groundwater investigation of AOC 6 based on field observations and laboratory analytical results showing petroleum-impacted soil at and immediately above the groundwater level. In planning the groundwater investigation and soil contamination delineation work, the location of similar contamination immediately above groundwater levels in AOC 1 and AOC 4 should be considered.

ENVIROSURE recommends delineation of the extent of PCBs exceeding the NJDEP's SRS in AOC 7. During the delineation of contamination, at least one sample should be collected on the three sides of the concrete pad not sampled during this SI.

Based on the laboratory analytical results, ENVIROSURE recommends delineation of the extent of elevated PCB concentrations exceeding NJDEP's RDCSRS.

The investigation of AOC 11 confirmed the presence of elevated concentrations of metals in fill material throughout Parcel A. ENVIROSURE recommends capping the elevated concentrations of metals during Site development. Upon completion of a redevelopment plan for the Site, a deed notice should be prepared for Parcel A.
